Los Lunas Habitat Restoration Project Progress Report for 2004–2005

Project Number: NMPMC-T-0404-RI

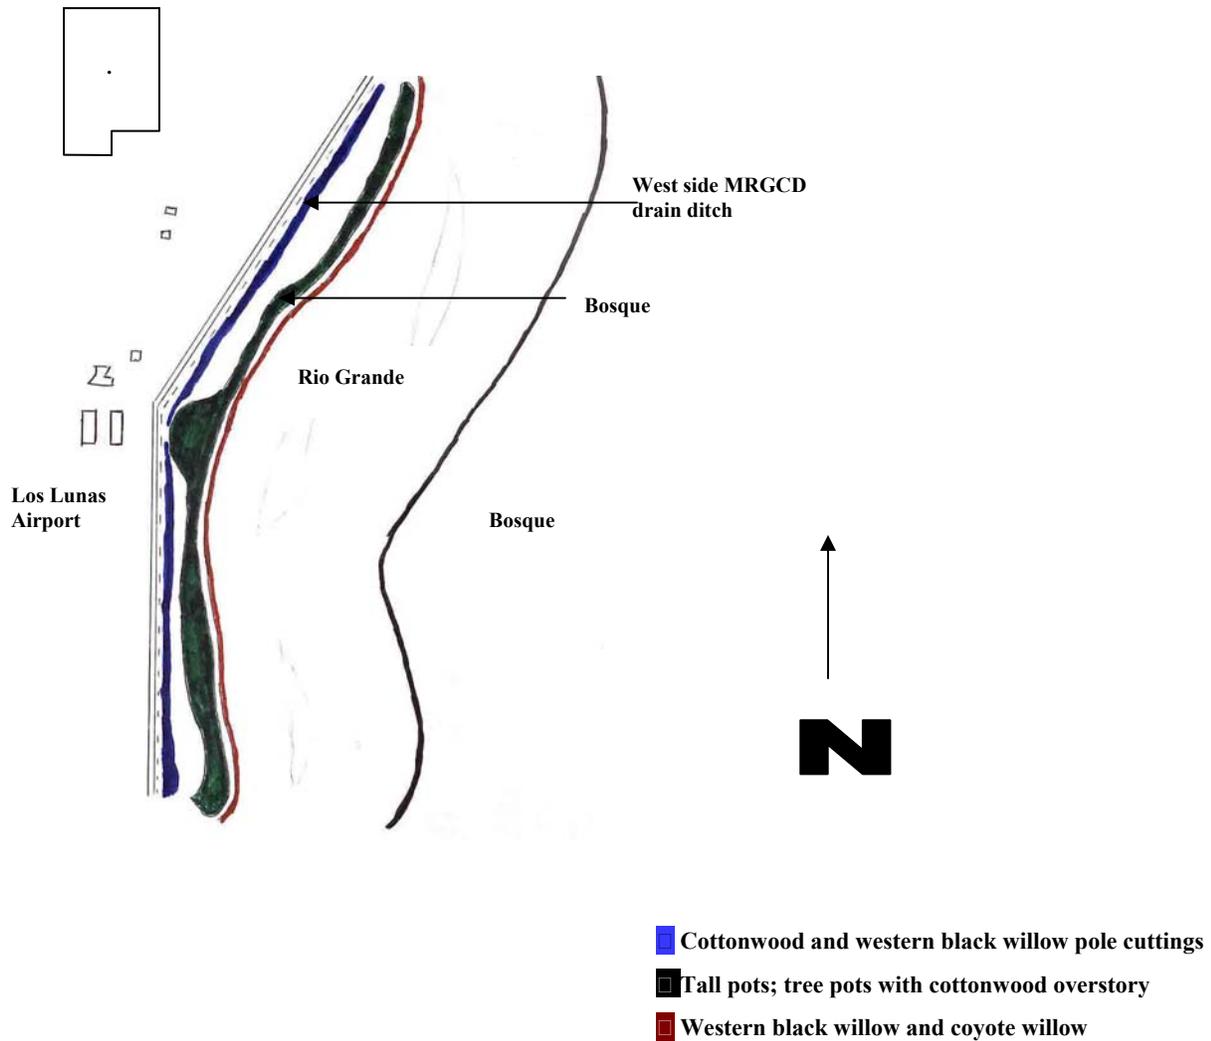
Figure 1: Map detail of the Los Lunas Habitat Restoration Project

The planting area consisted of two sites totaling approximately 16 acres and 1.2 miles in length (Figure 1). There are approximately eight acres along the MRGCD drain ditch road and approximately eight acres along the high-flow berm adjacent to the Rio Grande. The MRGCD requested us to leave a 30-foot open area along the berm for access to the site.

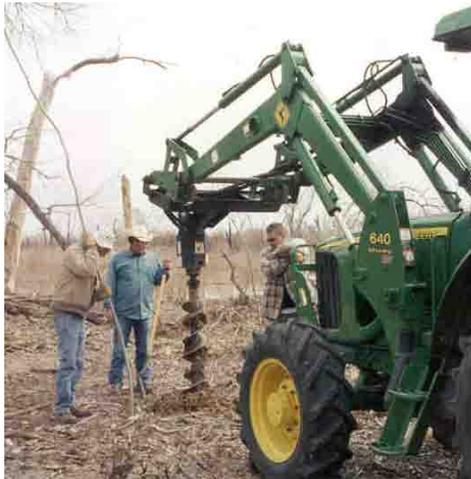
Figure 2: Planting cottonwood poles in April 2005

The planting holes were dug using a 65-hp farm tractor with a front-end mounted auger that was 9-inches in diameter and 8-foot in length (see Figure 2). We planted the poles on 15–30 foot centers. After planting the poles we placed a poultry-wire tree guard (5-foot in height and 10-inches in diameter) around each pole to control beaver predation.

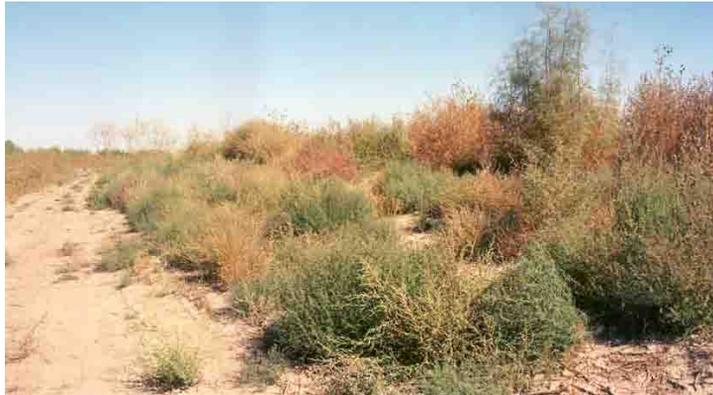
Figure 3: The grass seeding on high flow berm before mowing in July 2005 (looking north). The weeds are mainly Russian thistle and Kochia.

The seeding was mowed with a brush hog once in September 2004, once in July 2005, and once again in August 2005 to control annual weeds (Figures 3 and 4).

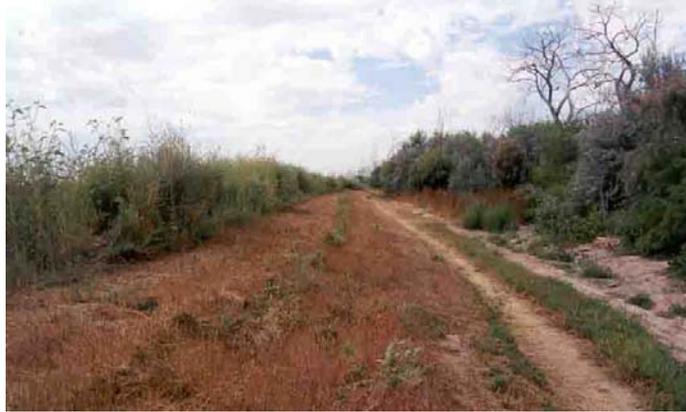
Figure 4: The grass seeding on high-flow berm after mowing in July 2005 (looking south).

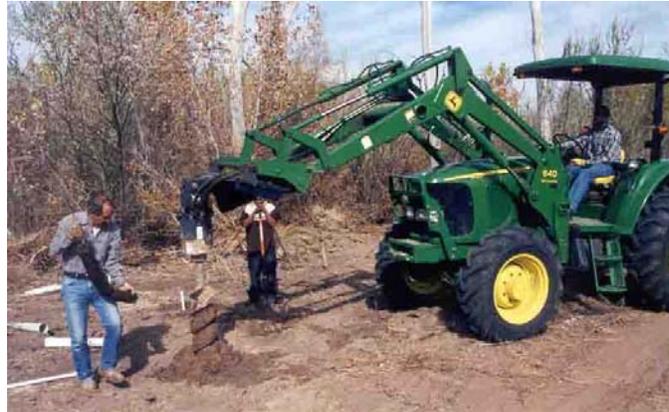
Figure 5: Planting New Mexico olive tall pot transplants with sub-irrigation tubes in November 2004.

The plants were planted to the depth of subsurface moisture, approximately 3- to 6-feet (Figure 5). Paired plantings of 100 New Mexico olive tall pot and 100 New Mexico olive tree pot transplants were planted within 8-feet from each other to test the effectiveness of the pot size on plant survival. An irrigation tube measuring 40-inches long and 1-inch in diameter was embedded with each transplant for future irrigation treatments. The lower $\frac{1}{3}$ portion of the tube was perforated to enhance water dispersion in the root zone of each plant.

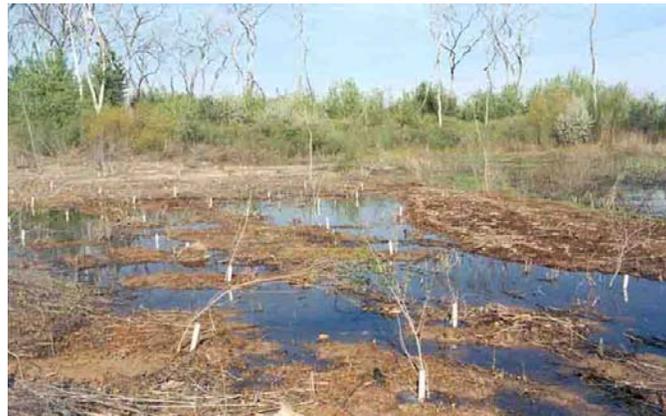
Figure 6: A typical inundated area of the planting with New Mexico olive tall pot transplants in the foreground in June of 2005.

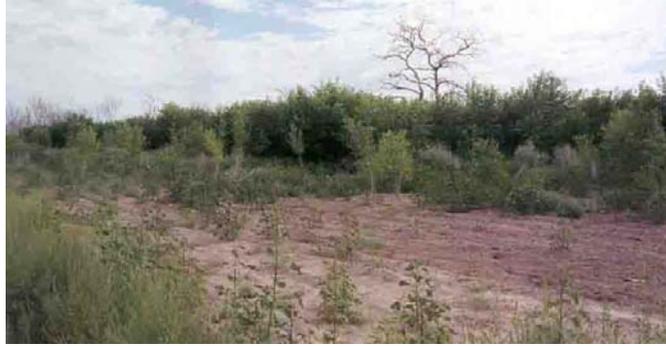
Figure 7: The second growing season for cottonwood pole cuttings planted at the side between the existing bosque and the MRGCD drain ditch road covered with a 4- to 6-inch surface mulch layer of wood chips. In the background where no surface mulching occurred, exists a dense ground cover of annual weeds in August 2005.

Leaving a 4- to 6- inch chip layer on the soil surface would have reduced the continued need for weed control. A mulch layer similar to this was left where the mulch piles once stood and after two years it is still controlling weed emergence (Figure 7). These sites are highly productive because of the presence of surface water and need to be protected from annual and new perennial weed emergence once they are disturbed.

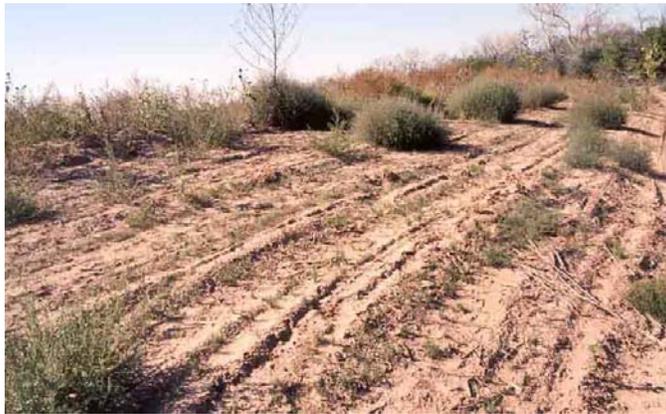
Figure 8: Grass emergence on the berm seeding in September 2004. The grass in the foreground is desert saltgrass, other grasses are mainly galleta and Indian ricegrass.

The berm grass and penstemon seeding began emerging in late August of 2004 after several rainstorms. Emerging seedlings of galleta and Indian ricegrass were the most common (Figure 8). Desert salt grass was also volunteering on the site. However, the seed bed was dominated by high densities of Russian thistle (*Salsola kali*) and kochia (*Kochia scoparia*) seedlings. Both plants are more competitive for light, water, and nutrients than grass seedlings. In retrospect, the site should have had weed control applied for at least two years prior to seeding to reduce this competition. As of August 2005, the berm is still dominated by weeds with some grass plants present. Unlike the other species seeded, New Indian ricegrass and penstemon seedlings will continue to emerge for the next two years.

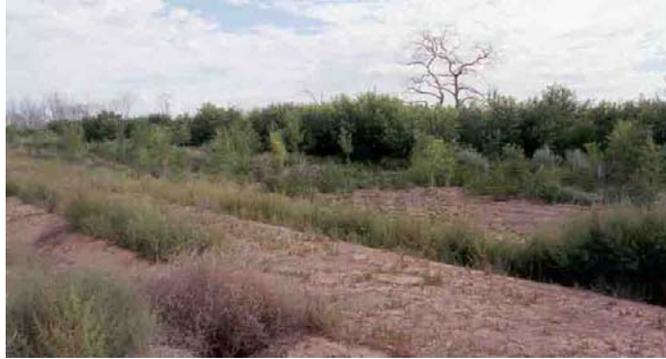
Figure 9: Cottonwoods poles cuttings in their second year planted along the MRGCD drain ditch road in August 2005.

Of the 600 pole cuttings planted in the April of 2004 (580 cottonwood and 20 western black willow), only 384 cottonwood and 17 western black willow were found, approximately 67 percent of the plants (Figure 9). The others are in a dense forest of 10–12 foot kochia, sunflowers, coyote willow and other vegetation. Of the plants that were located, the cottonwoods averaged 84 percent survival and the western black willow averaged 76 percent survival. The 50 days of inundation did not seem to have an effect on the survival of the poles that had already rooted one year earlier.

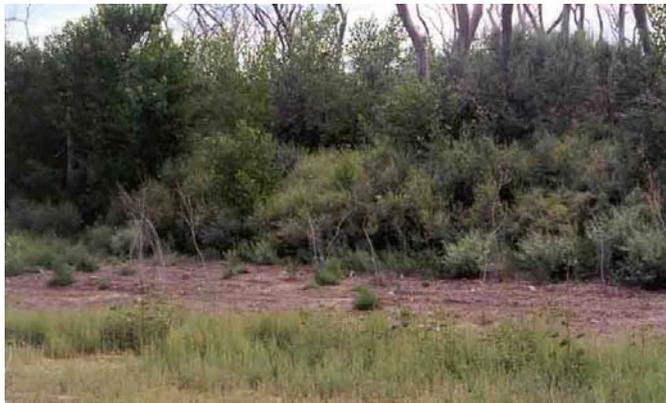
Figure 10: In July 2005 three months after planting, these cottonwood pole cuttings had dropped their leaves and are probably dead.

However, of the 410 cottonwood pole cuttings planted in March and April 2005, the survival rate averaged only 27 percent. The trees were affected by the 50 day plus inundation which occurred from May to July of 2005. The pole cuttings leafed out in May as they typically do, but they began to show signs of chlorosis by mid-June, and by July (Figure 10) they had dropped their leaves. Those plants that did survive were located on slightly higher ground within the planting. Similar survival results occurred on a new planting of cottonwood poles about 15 miles south of this planting. This similar planting was also inundated, and most of these pole cuttings also died except for those that were planted on higher ground.

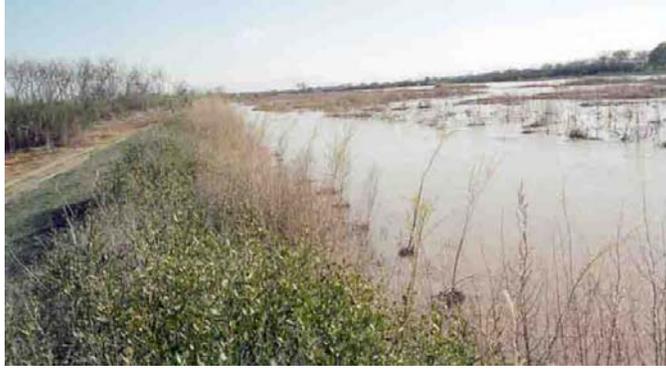
Figure 11: Western black willow pole cuttings planted on the toe of the high-flow berm are inundated in June 2005.

Survival of the western black willow planted on the toe of the berm averaged 53 percent as a consequence of inundation (Figure 11). Those planted in sandy top soil seemed to have a higher survival rate (Figure 12). There were areas within the planting that had 30 or more consecutive dead willows that seemed to correlate to clay soil surface texture which may provide less air for root respiration under saturated conditions. Traditionally, survival averages above 70 percent when conditions are ideal and the plants are not inundated. Survival of the coyote willow averaged about 75 percent even though they were planted in a slightly lower area than the western black willow (Figure 13). They appear to display a better tolerance to inundation than the western black willow. Some of the coyote willows were damaged by beaver. However the stems that were cut all had new growth. The western black willows with the beaver guards were left intact.

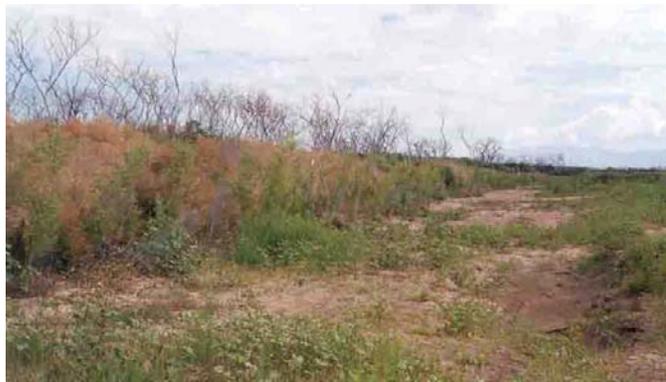
Figure 12: Western black willow pole cuttings five months after planting on sandy topsoil in August 2005.

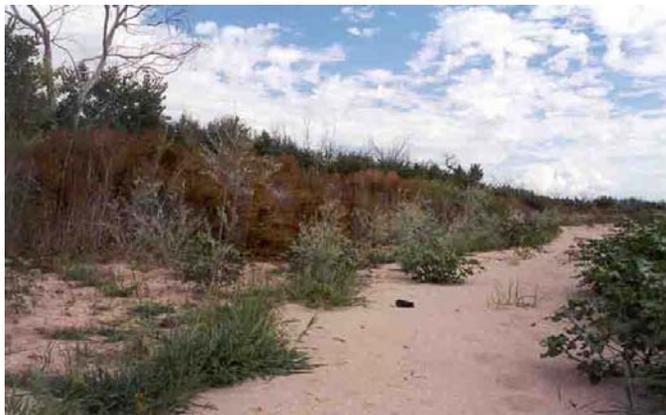
Figure 13: Coyote willow pole cuttings (center) four months after planting in the high-flow channel in August 2005.

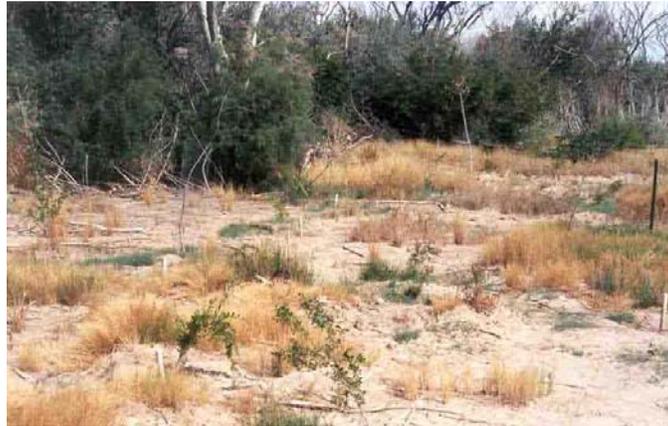
Figure 14: New Mexico olive tall pot transplants in foreground 8 months after planting in August 2005.

Of the 700 New Mexico olive tall pot transplants, 609 plants were found. The plants averaged a 93% survival rate (Figure 14). The inundation did not have a significant impact on New Mexico olive tall pot survival. These plants can tolerate this extended period of inundation.

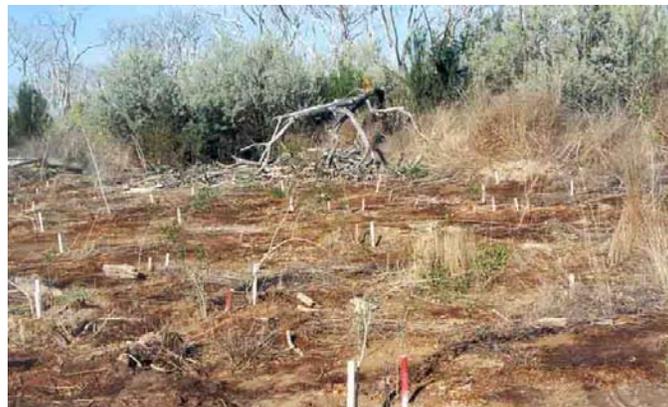
Figure 15: Survival test of New Mexico olive tall pots (white tubes) compared to New Mexico olive tree pots (red tubes) planted next to each other in paired plots in July 2005.

Survival of the New Mexico olive tallpots (89 %) was significantly greater (.0001) than survival of the treepots (14 %) in the paired plot trial (see Figure 15). The tree pot transplants broke dormancy in May and dropped their leaves in June and then died while the soil was still inundated. These plants have smaller root system (10–12 inches in length) compared to the root system of plants grown in tallpots (25–27 inches in length). The larger root systems of plants grown in tall pots may have allowed the plants to tolerate inundation for a longer period of time. The buried stem of the tree pot plants would be less tolerant of inundation.
